# HOME INSPECTION REPORT Prepared Exclusively For: Joe Home Owner emial@email.com, (123)-456-7890

Inspected by Cole Stevens, Lic.#: 24371 on 02/09/2021 Phone: (214)208-8238, Email: cole-stevens@att.net

# Stevens Home Inspections, PLLC

Report Identification: 20210209-01, 123 Happy Place, Melissa, TX I=Inspected NI=Not Inspected **NP=Not Present D=Deficient** NI NP D I. STRUCTURAL SYSTEMS A. Foundations Comments: Foundation Type: Slab on Grade Future performance of the structure cannot be predicted or warranted. This inspection is one of first impressions and the inspector was not provided with any historical information pertaining to the structural integrity of the inspected real property. This is a limited cursory and visual survey of the accessible general conditions and circumstances present at the time of this inspection. Opinions are based on general observations made without the use of specialized tools or procedures. Therefore, the opinions are based on general apparent conditions and not of absolute fact and are only good for the date and time of this inspection. Weather conditions, drainage, leakage and other adverse factors are able to effect structures, and differentia

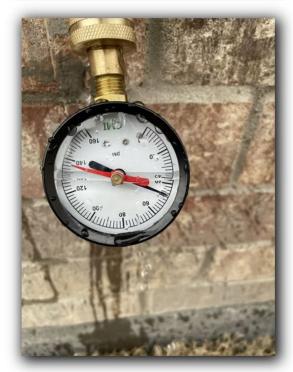
☑ The visible water supply system (plumbing) was inspected according to today's Texas Standards of Practice and or local code and was performing as intended at the time of the inspection. Portions of the plumbing system that were concealed by finishes, stored items, below grade or in or under the foundation were not visible and were not inspected.
